Property Inspection Report

***1220 Mill Street, San Luis Obispo, CA 93401
Inspection prepared for: Ida Mae Gracia
Real Estate Agent: Kristi Donati - The Avenue Central Coast Realty***

***Date of Inspection: 3/10/2022 Time: 9:00 AM
Age of Home: 1910 Size: 1480
Order ID: 8356***

***Inspector: Gus Vasquez
CREIA CCI #0155505***

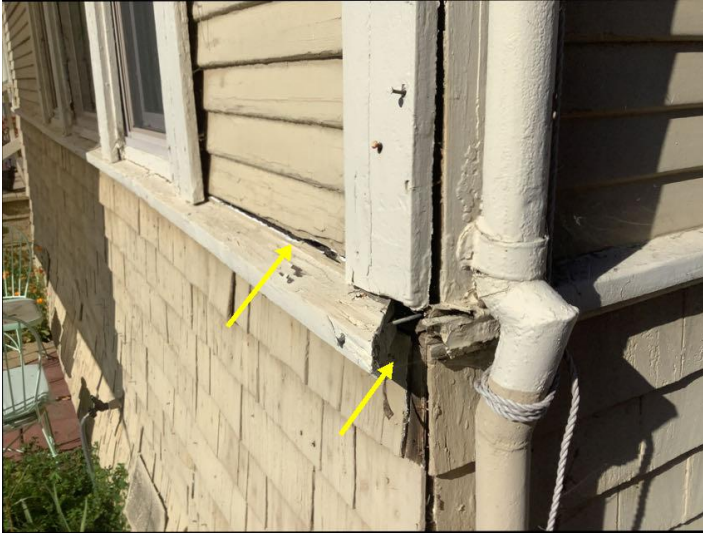
The siding needs typical maintenance such as sealing and painting. This should include caulking and filling gaps or openings such as small cracks or openings at hose bibs, and sealing with a proper primersealer, then one or two finish coats.

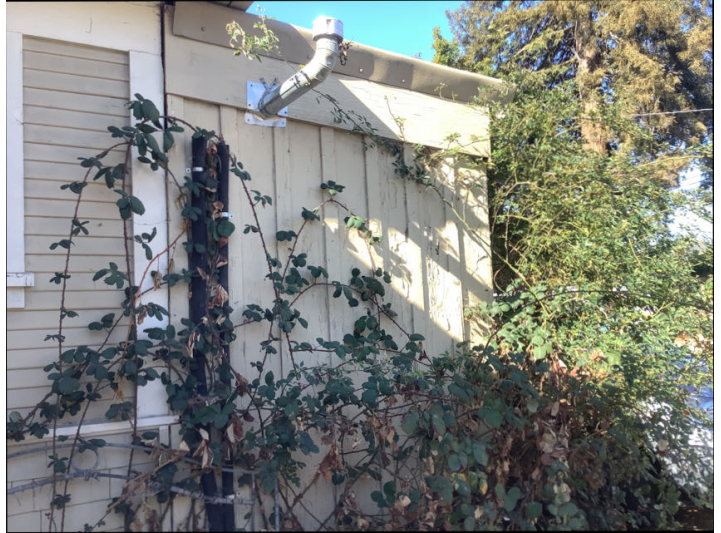
Vines, shrubs or bushes are growing on the house walls and although they are attractive they can introduce pests and rodents and accelerate deterioration. Therefore, you may wish to consider having them removed or cut back to 12 inches away from the home.

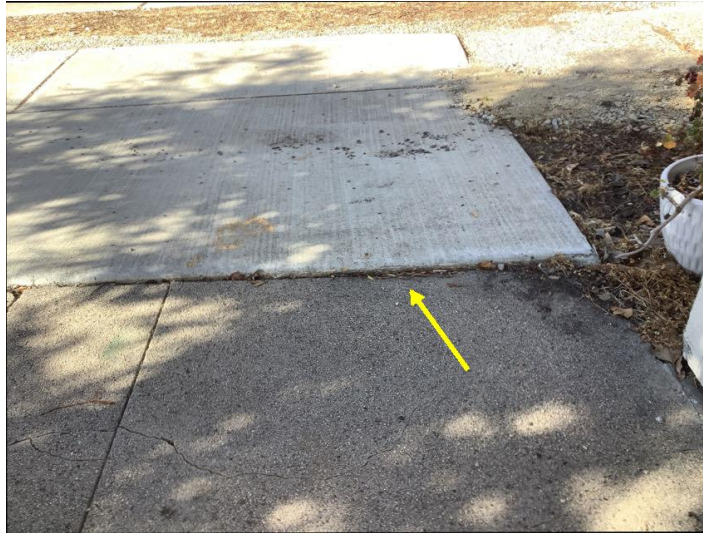
There is one or more offsets in the walkways that could prove to be trip-hazards.

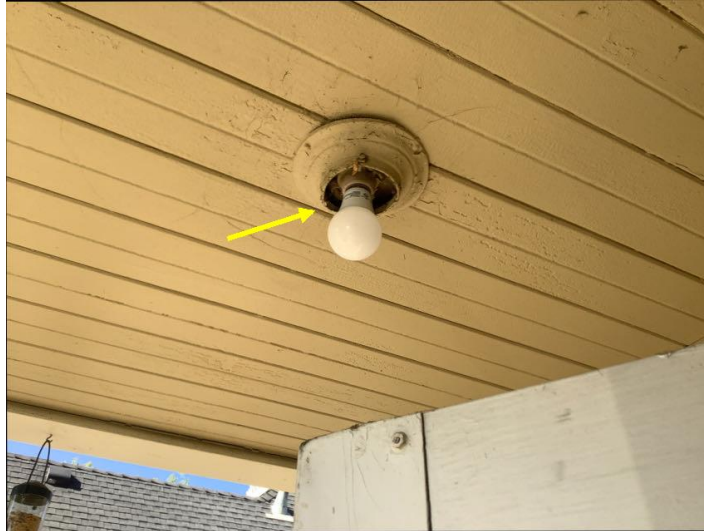
A light is missing its globe or cover and should be serviced.

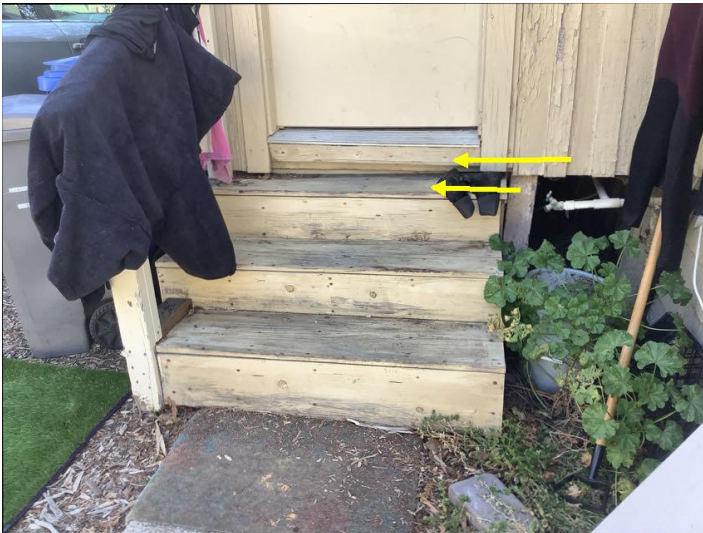
Some of the steps have unequal treads or risers. Steps are required to be uniform to prevent trip-hazards. The rise of any step should be no less than four inches and no greater than seven inches, and the run should be no less than eleven inches. Also, the dimensions of the largest step should not exceed that of the smallest by more than three-eighths of an inch.

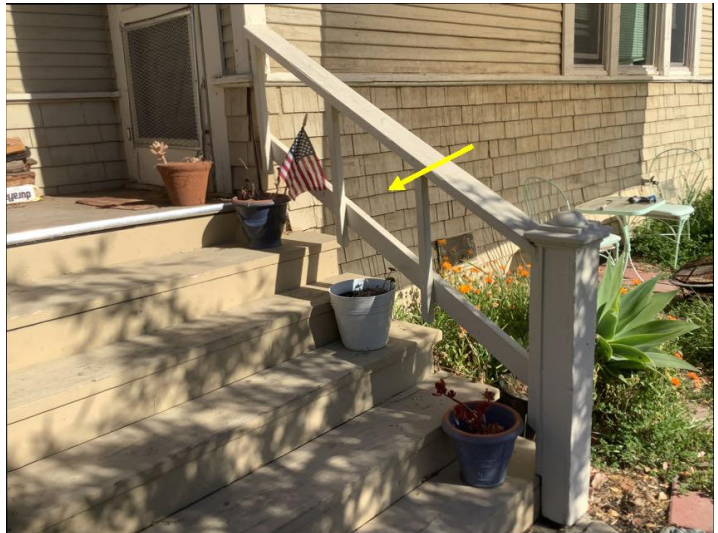
The balusters in the stair handrail and/or guardrail are more than 4" apart and do not meet current standards for child safety. We recommend servicing to meet this standard.

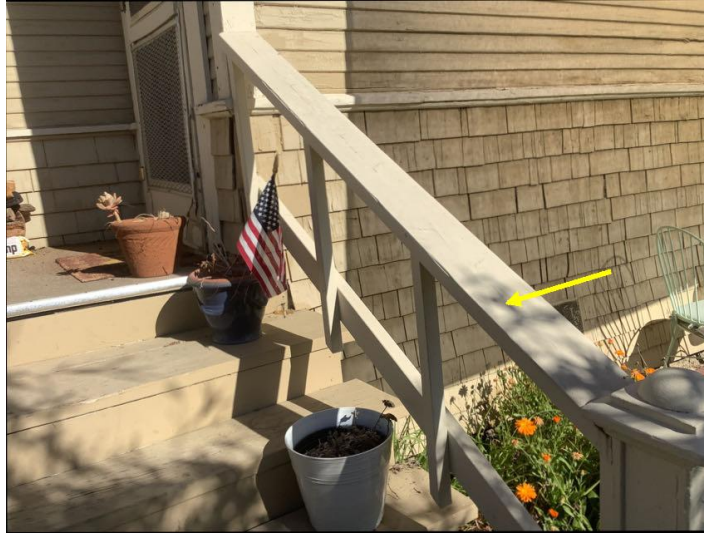
The handrail does not meet current standards as graspable, meaning fingers and thumb can rap around or into grooves so a hand would not easily slip off the handrail.

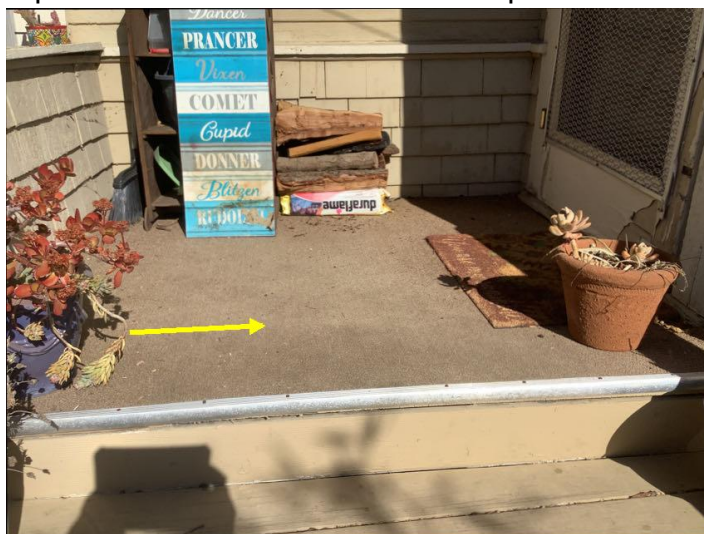
The wooden deck or porch floor is covered and our inspection is limited.

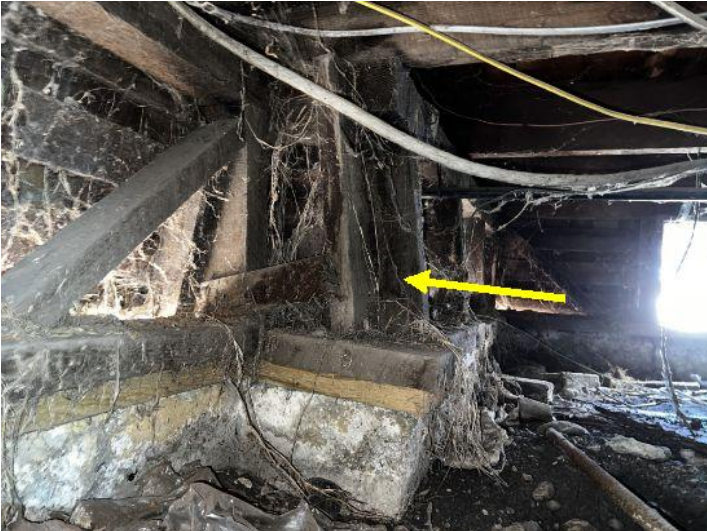
The cripple walls have been seismically displaced or have settled out of plumb, and should be evaluated by a specialist.

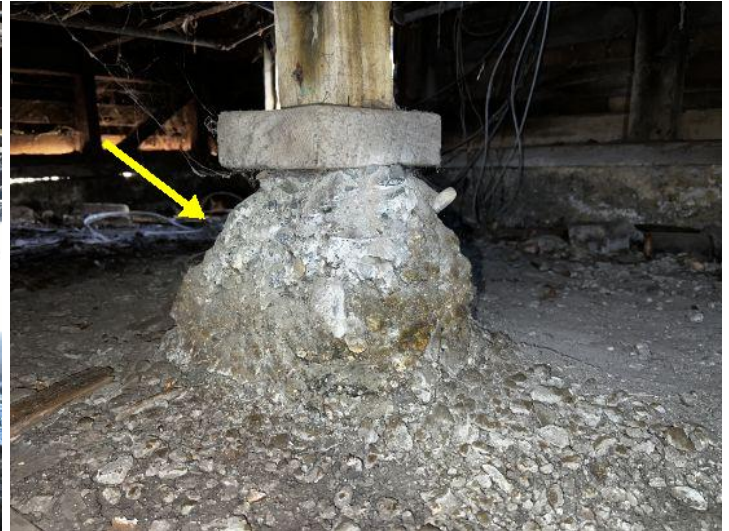
Concrete is sloughing off the foundation walls due to its age which should be evaluated by a foundation contractor.

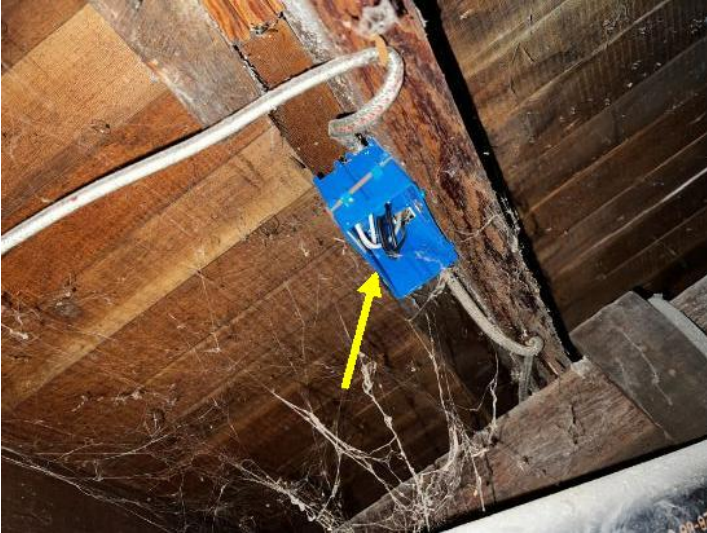
There is an open electrical junction box, which presents a fire hazard. All junction boxes should be sealed so that any arcing or sparking would be contained within the box.

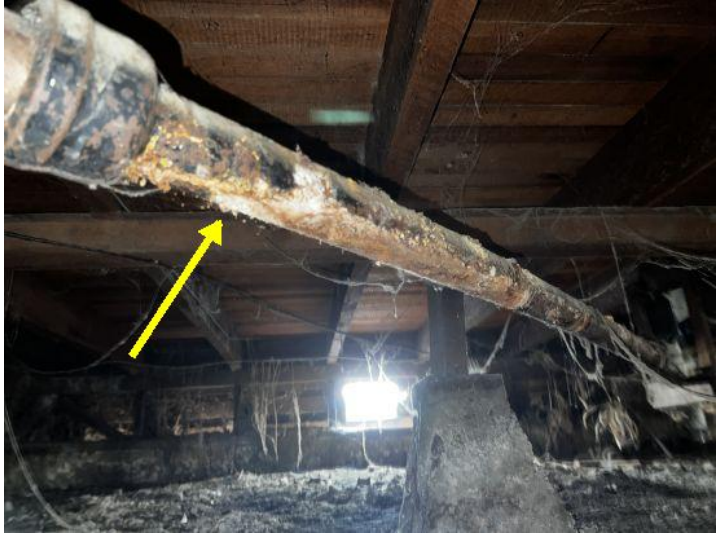
The cast iron drain waste pipes in the crawlspace are beyond their designed life, portions are rusting and should monitor for replacement.

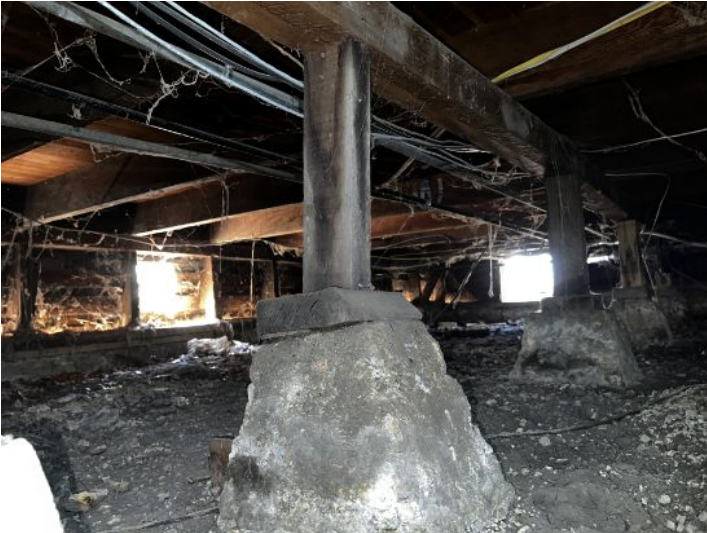
Concrete is sloughing off the foundation walls due to its age which should be evaluated by a foundation contractor.

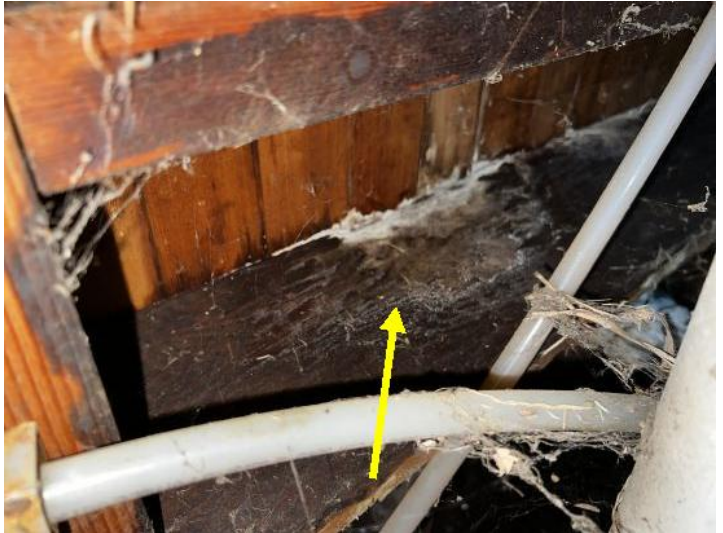
There are moisture stains beneath the bathroom which should be evaluated by the termite inspector.

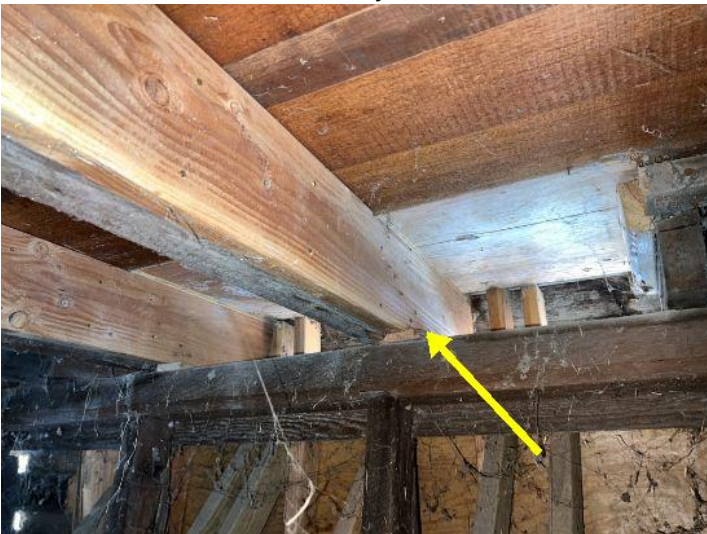
We noted repair made. The repairs appear to be a stop gap and not very effective. We recommend further evaluation by a qualified licensed foundation specialist.

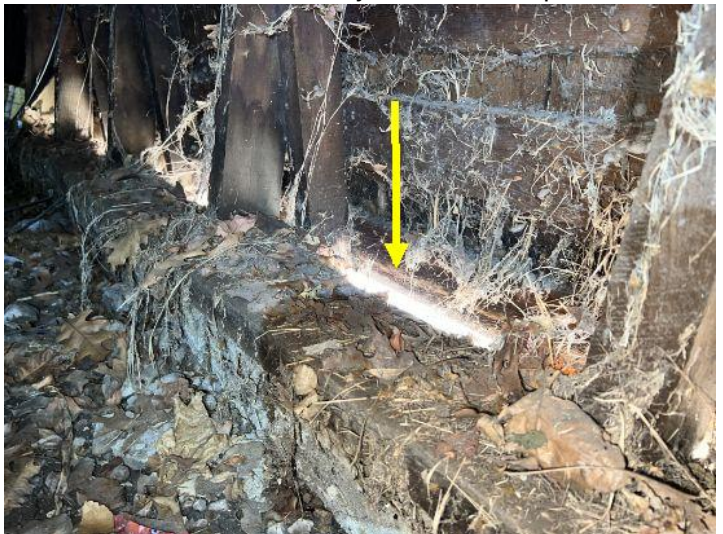
There are gaps or openings which could allow pests to enter. We recommend they be covered with 1/4 wire mesh to prevent rodent access.

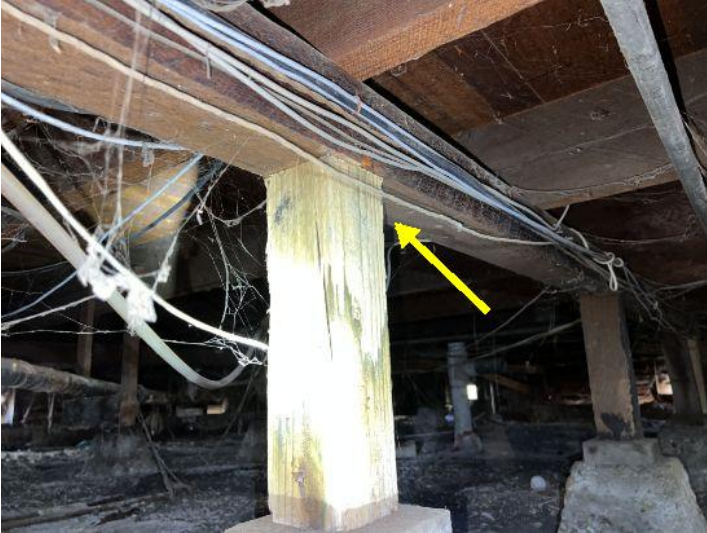
We recommend metal connectors be added as part of an upgrade to the posts and piers.

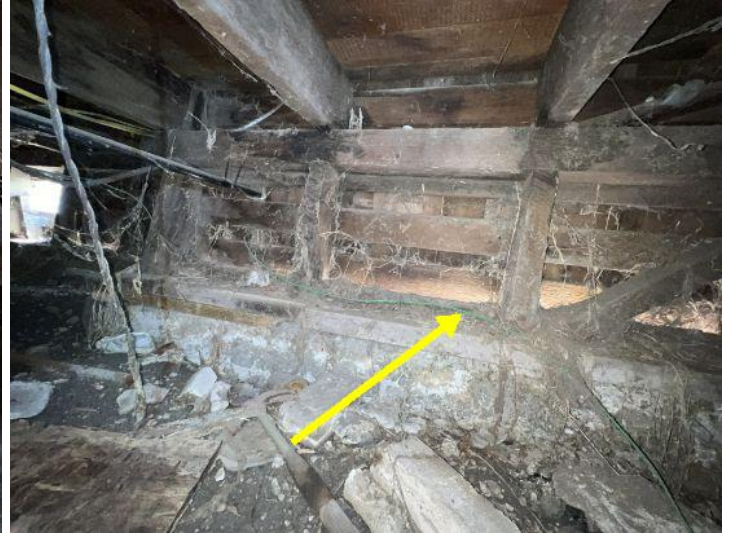
The cripple walls have been seismically displaced or have settled out of plumb, and should be evaluated by a specialist.

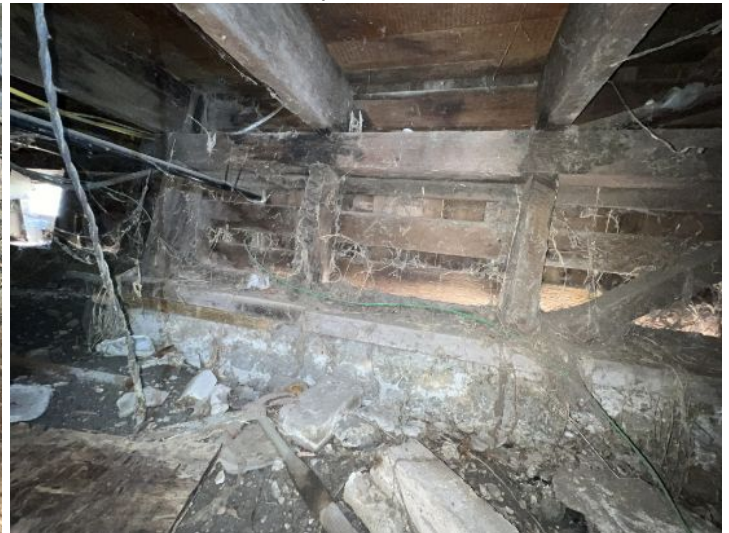
The cripple walls have been seismically displaced or have settled out of plumb, and should be evaluated by a specialist.

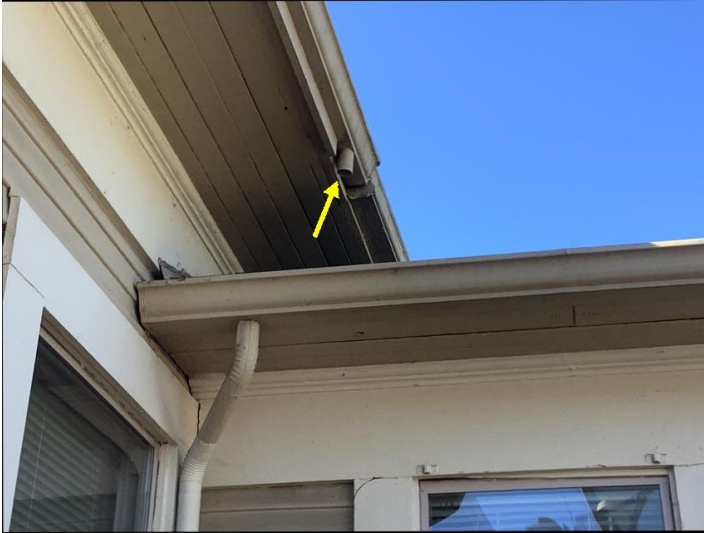
Some downspouts are missing or need to be reconnected, and should be serviced.

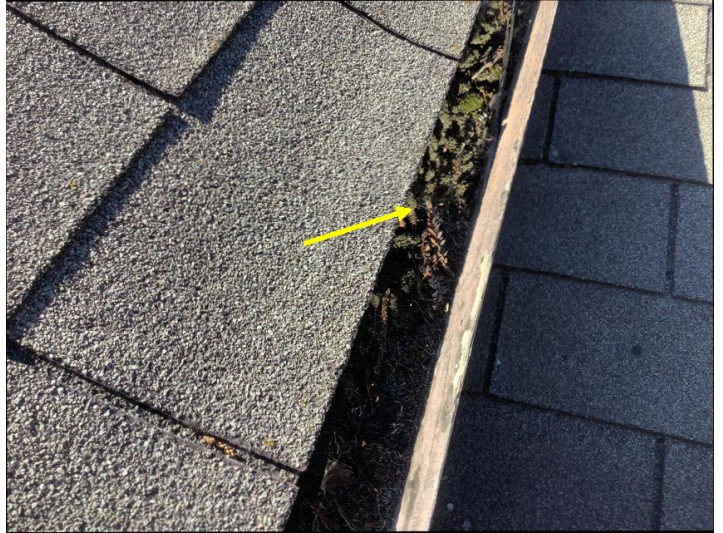
The gutters need to be cleaned to drain properly.

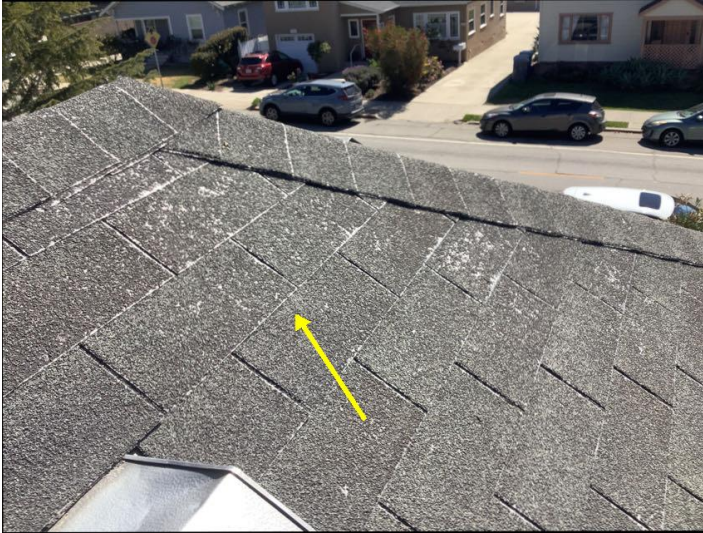
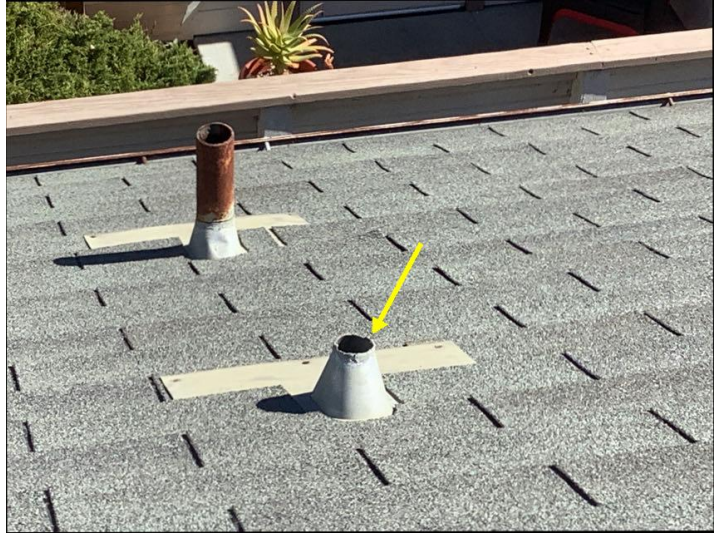
The composition shingle roof is in the primary stages of decomposition, which means that the roof is in decline and while it is still in acceptable condition it will become more susceptible to leaks. It will need to be maintained and closely monitored, because it is approaching the end of its serviceable life, and you may wish to have a second opinion before the close of escrow.

There is a penetration on the roof that is open and should be sealed.

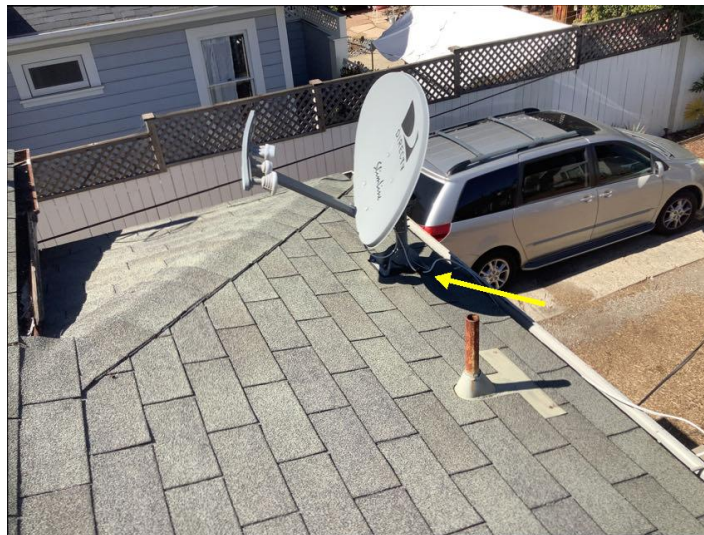
The roof includes a satellite dish that has been installed by bolting through the roof, which can be a common point of leaks and should be monitored.

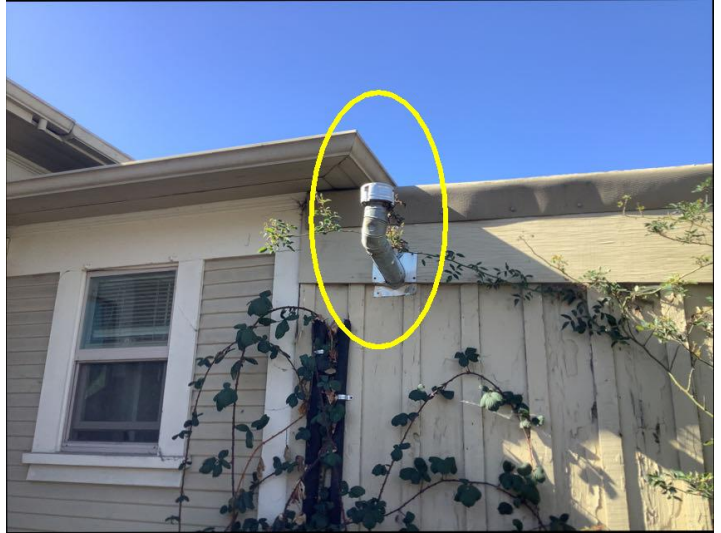
The vent pipe should extend at least 3 feet above the roof line and a minimum 5 feet above the flue collar, to safely discharge the bi-products of combustion beyond the residence, and should be serviced.

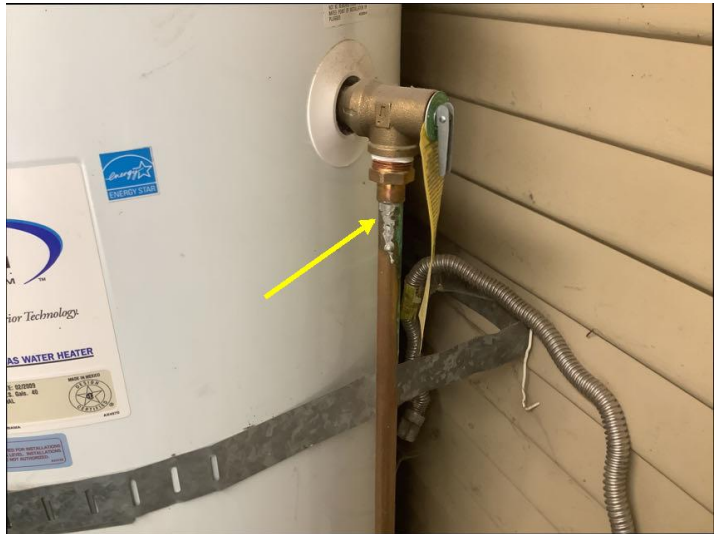
The diameter of the discharge pipe from the pressure relief valve on the water heater has been incorrectly reduced in size and should be replaced by a licensed plumber before the close of escrow.

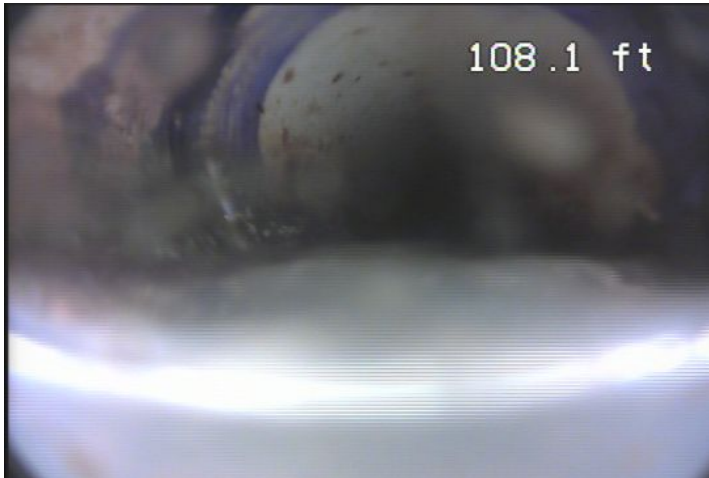
There is a low point in the drain line, which will promote clogging. We recommend further review and repair as needed.

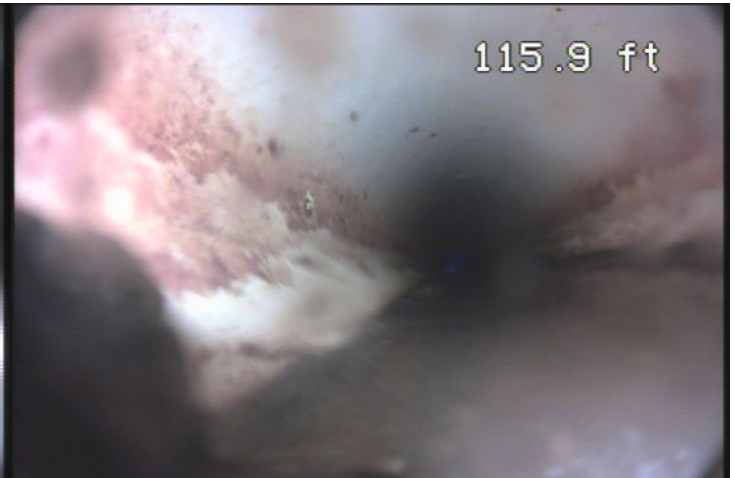
There is a low point in the drain line, which will promote clogging. We recommend further review and repair as needed.

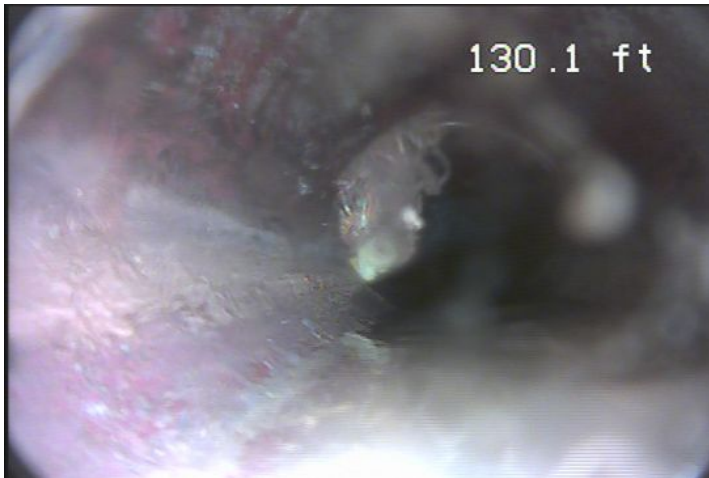
There is root growth present, in the clay pipe connections, which is commonly a result of a damaged drain line or void in a joint. We recommend further review and repair as needed.

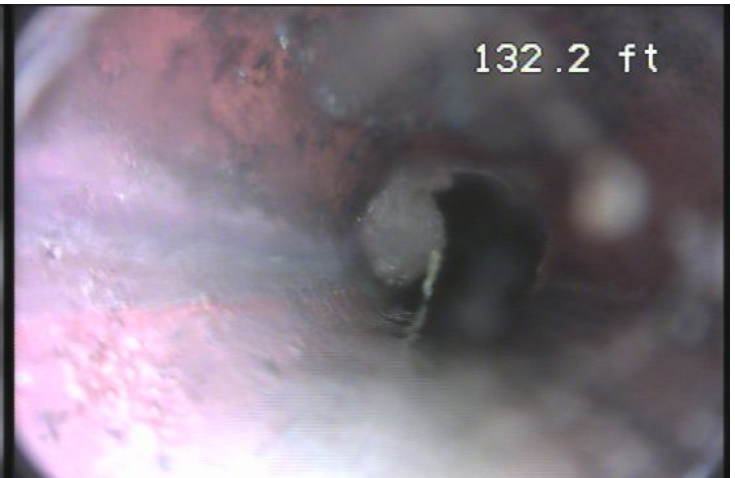
There is root growth present, in the clay pipe connections, which is commonly a result of a damaged drain line or void in a joint. We recommend further review and repair as needed.

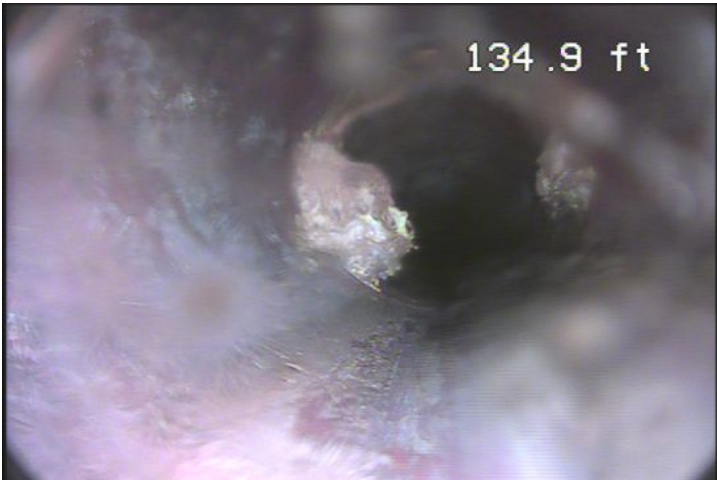
There is root growth present, in the clay pipe connections, which is commonly a result of a damaged drain line or void in a joint. We recommend further review and repair as needed.

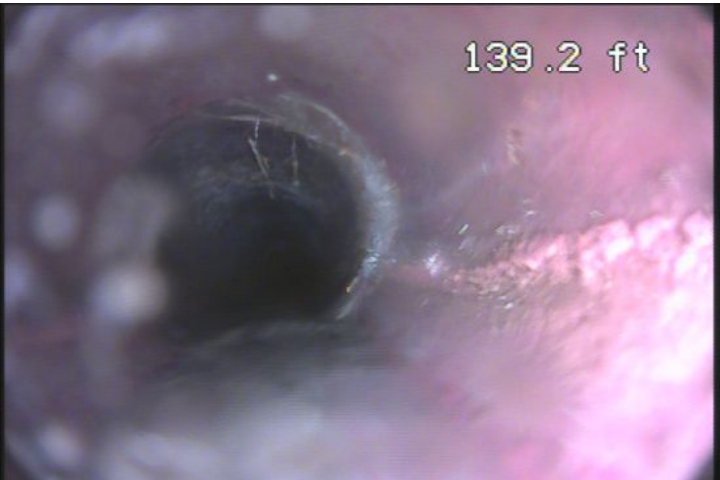
There is root growth present, in the clay pipe connections, which is commonly a result of a damaged drain line or void in a joint. We recommend further review and repair as needed.

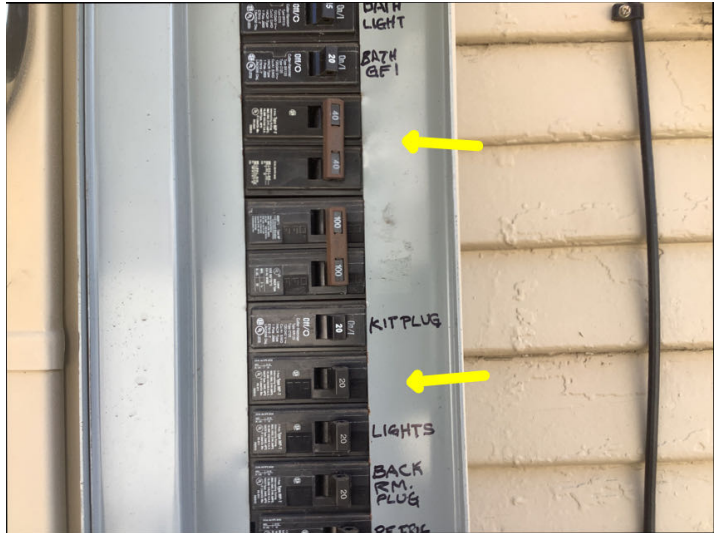
Various circuits are not labeled, which is recommended.

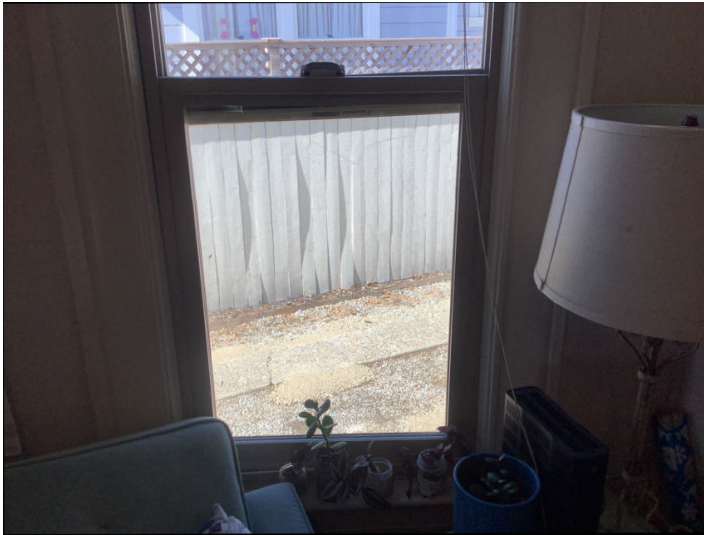
A window is out of square which indicates movement and damage to the foundation. We recommend further evaluation by a licensed foundation contractor and serviced as required.

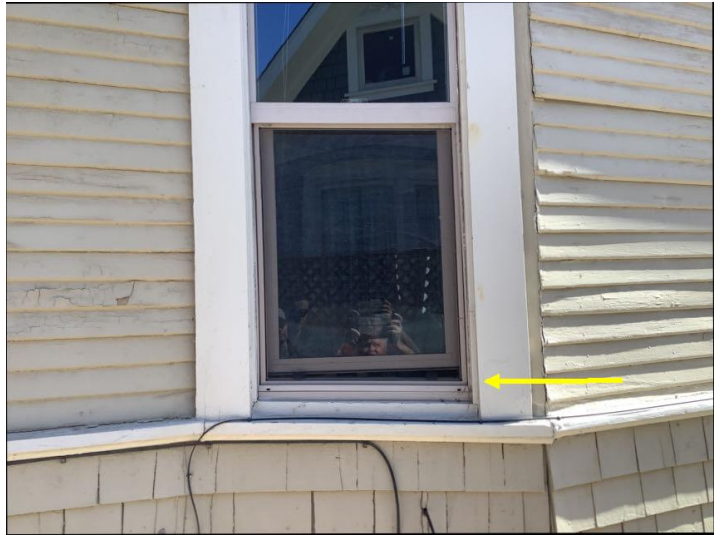
A window is out of square which indicates movement and damage to the foundation. We recommend further evaluation by a licensed foundation contractor and serviced as required.

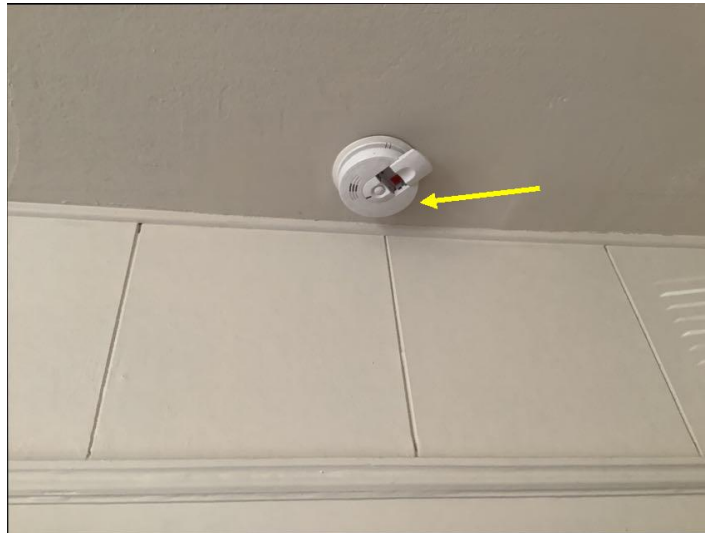
The smoke alarm may not be in the location recommended by the manufacturer. We can elaborate but you may wish to verify this.

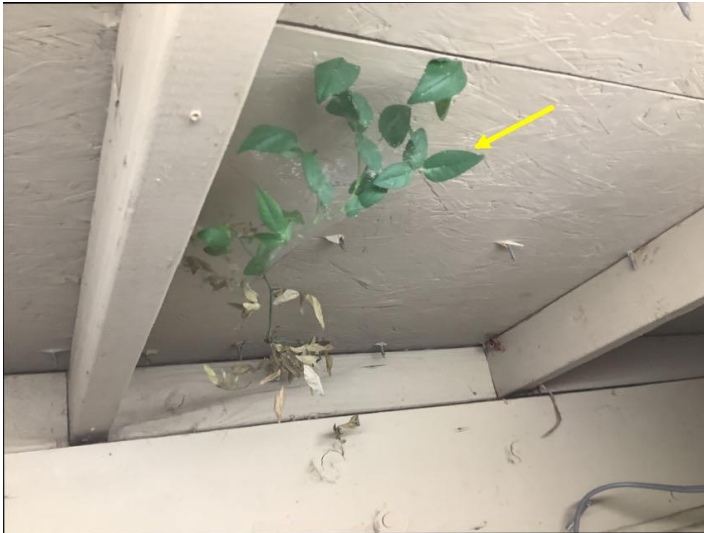
Vines are growing through the wall and into the laundry room. We recommend this be serviced to prevent damage from the vegetation.

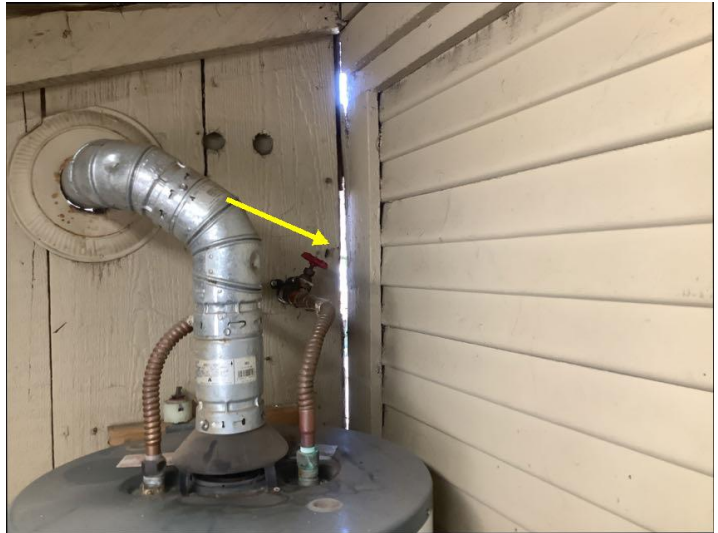
There are large large gaps in the wall. We recommend further evaluation by a qualified contractor and serviced as required.

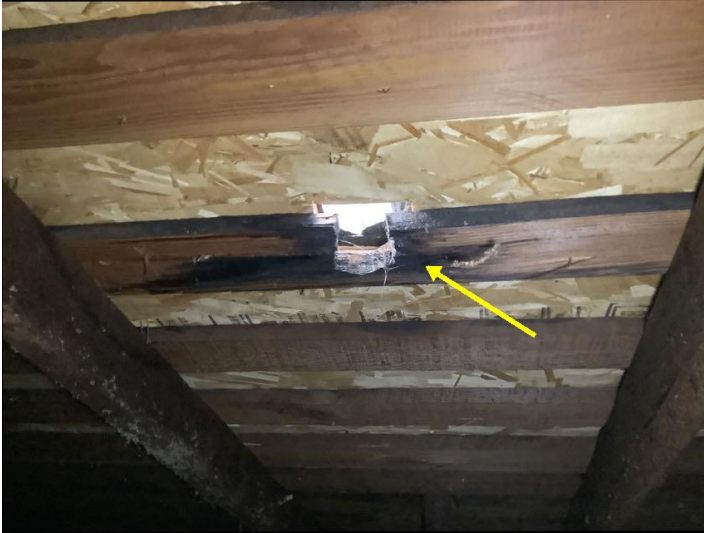
There are moisture stains on the attic ceiling at a roof penetration that indicate a past or present leak. This is a common area for leaks. We are unable to determine if the leak is current, or a past leak, in any case it should be further investigated or explained. A penetration no longer has a vent pipe through it and is open which will allow moisture intrusion.

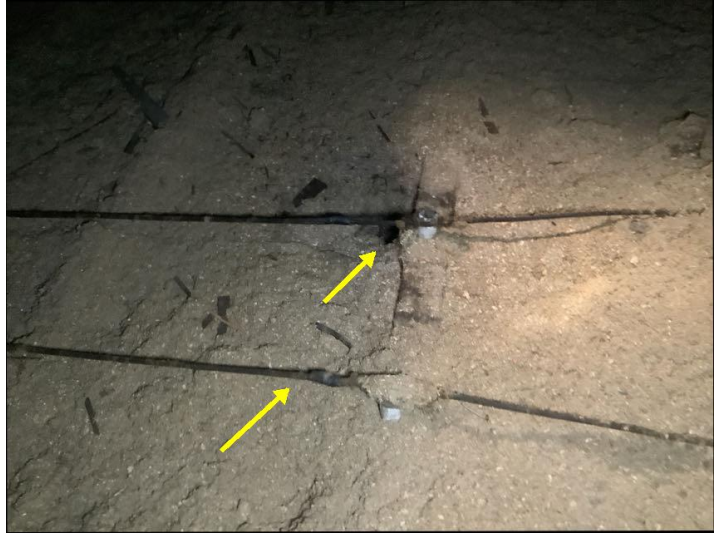
There is insulation and knob end tube wiring present which is a safety hazard which should be evaluated by a licensed electrical contractor.

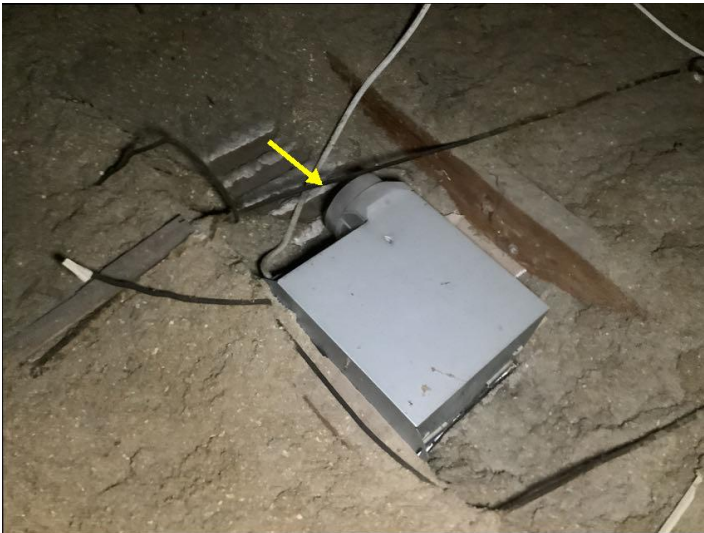
The 1st guest bathroom exhaust duct should be extended to an exterior port.

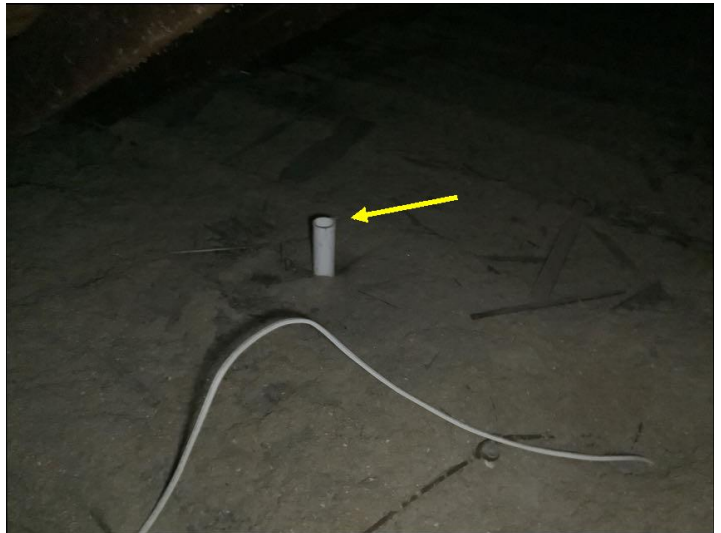
A vent pipe terminates in the attic and should terminate 6" or more above the roof. This issue should be repaired by a licensed plumber.

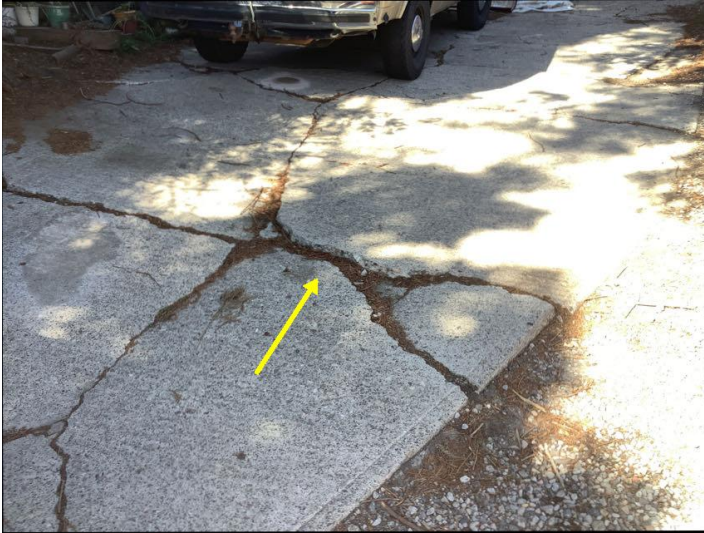
There are significant cracks or offsets in the driveway, which could prove to be trip-hazards that you may wish to have repaired.

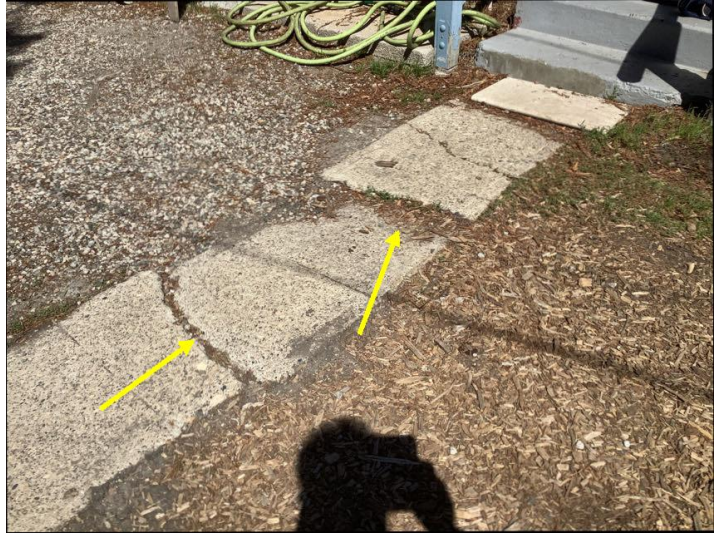
There are several offsets in the walkways that could prove to be trip-hazards.

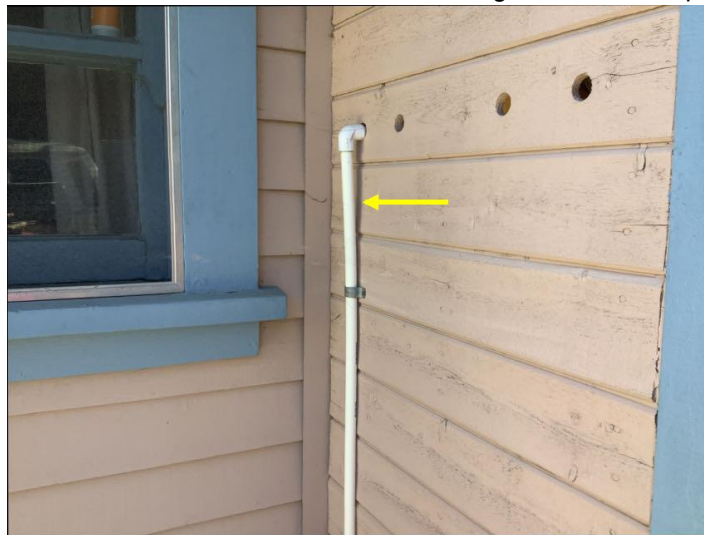
Some of the water supply lines have been plumbed with landscape grade **PVC** pipes, which is not recommended, and not allowed in most jurisdictions.

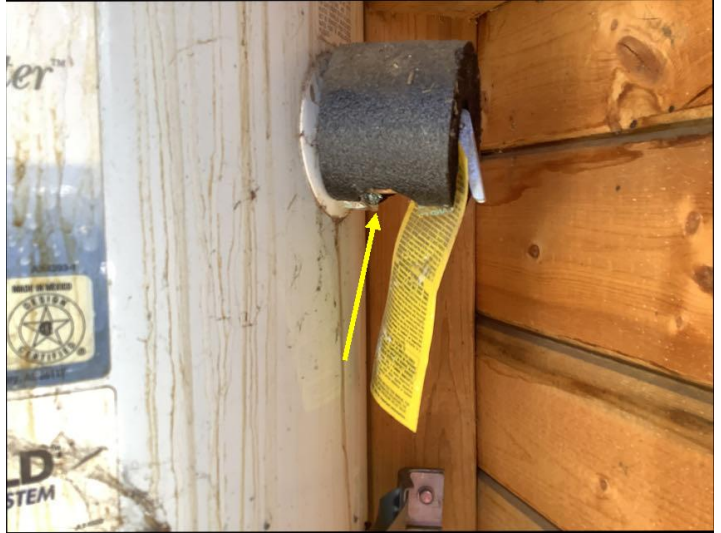
The pressure relief valve on the water heater does not have a discharge pipe. One should be installed to terminate no more than 24 inches above grade and no closer than 6 inches to it and be directed down towards the ground.

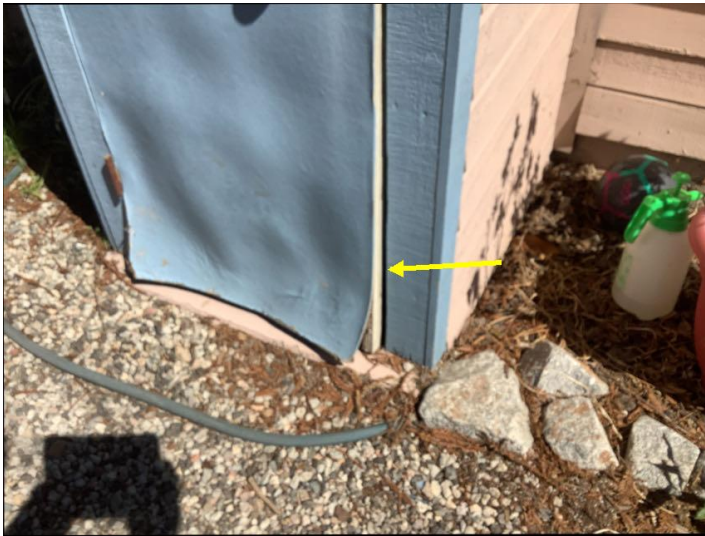
The base of the water heater closet door is moisture damaged and delaminating, and should be repaired.

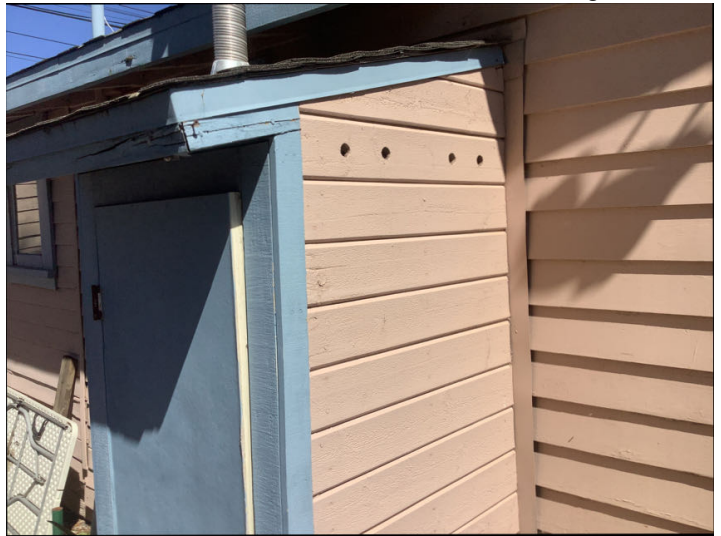
There is inadequate **combustion air** vent ports on the water heater door to achieve complete combustion. We recommend installing new ventilation port screens or enlarging the existing ports to current standards.

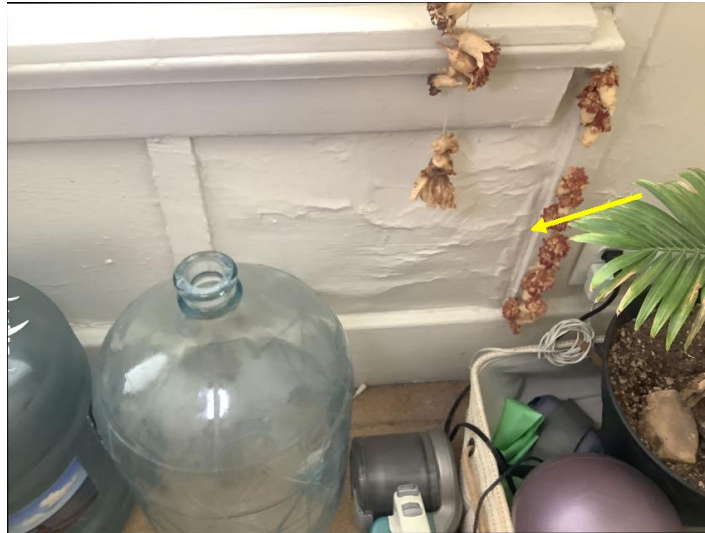
There is a moisture damage to the wall under the front window that should be explained or explored further.

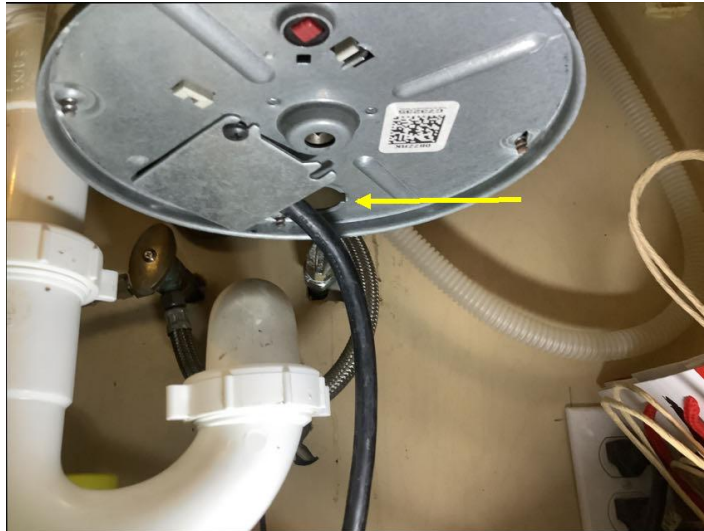
The electrical connection to the garbage disposal is substandard. The approved appliance cord is missing its protective clamp.

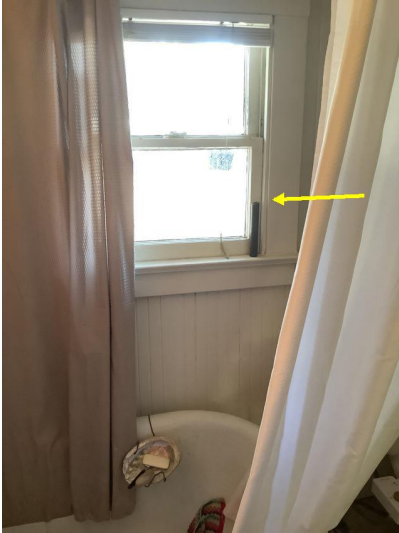
A window or windows within 60 inches of the standing surface of the tub or shower is not identified as safety-glazed or tempered, which is required to be for safety reasons. We recommend further evaluation by a window specialist.

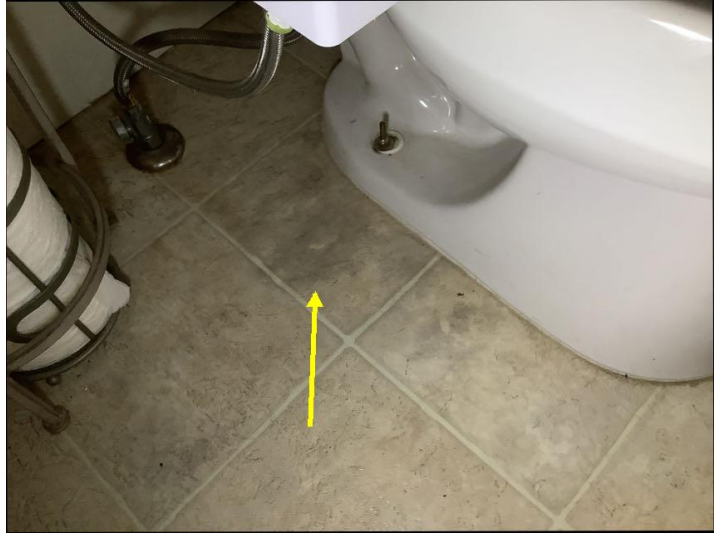
The floor is moisture stained and should be evaluated by a termite inspector.

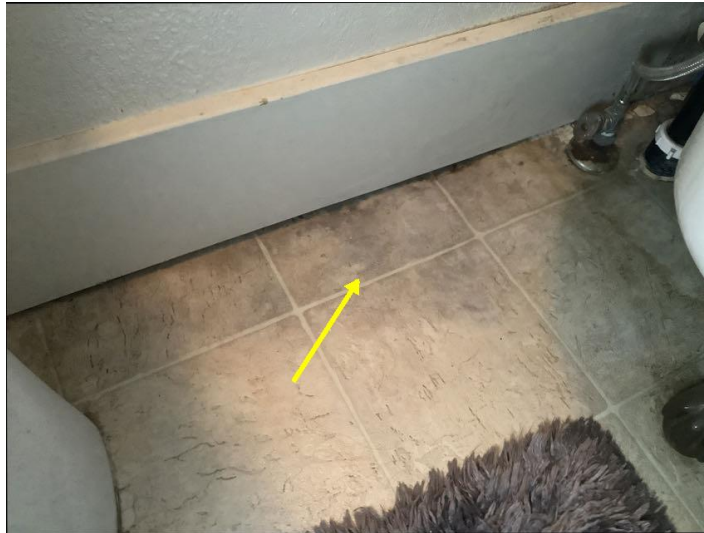
The floor is moisture stained and should be evaluated by a termite inspector.

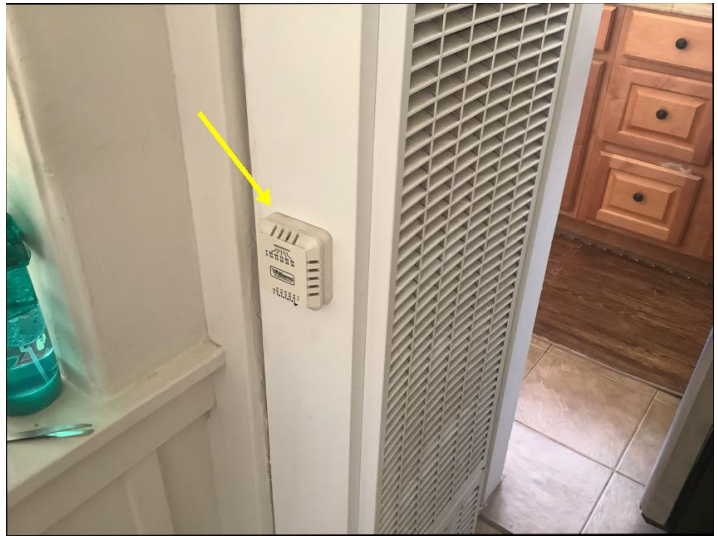
The thermostat is not in the best possible location for the optimum performance and efficiency of the system, and you may wish to have an HVAC contractor apprise you on the advantages of relocating it.
