Property Inspection Report

***1220 Mill Street, San Luis Obispo, CA 93401
Inspection prepared for: Ida Mae Gracia
Real Estate Agent: Kristi Donati - The Avenue Central Coast Realty***

***Date of Inspection: 3/10/2022 Time: 9:00 AM
Age of Home: 1910 Size: 1480
Order ID: 8356***

***Inspector: Gus Vasquez
CREIA CCI #0155505***

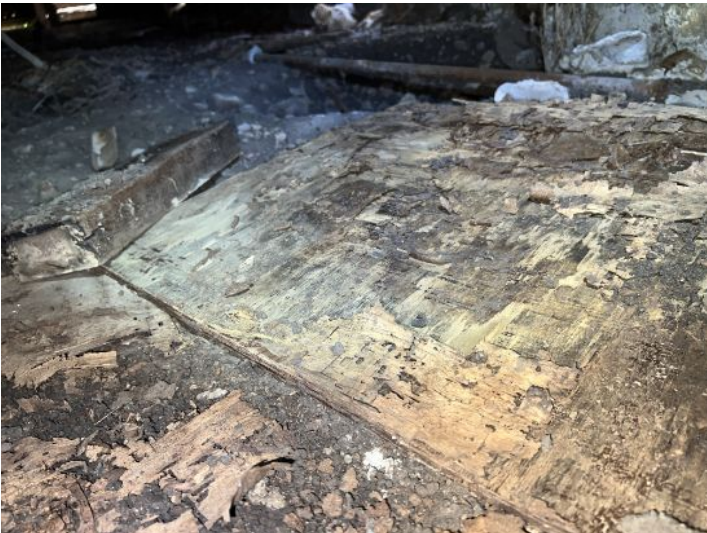
There is cellulose debris in the crawlspace that should be removed.

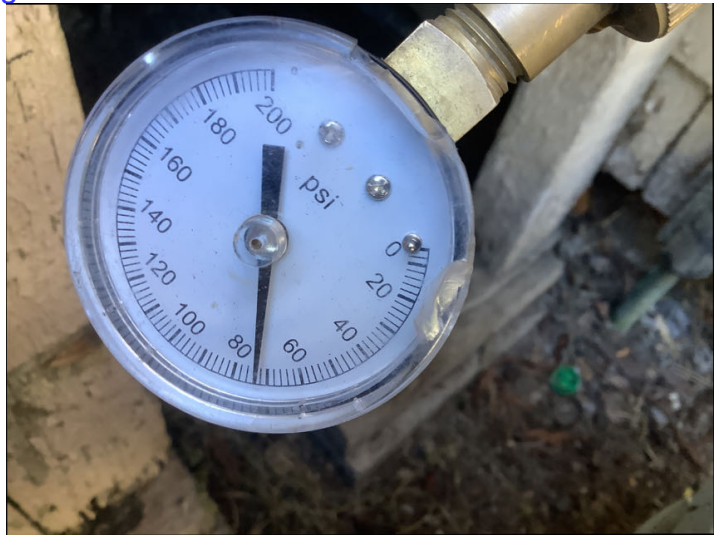
The water pressure entering the residence is under 80psi and a regulator is not required on the plumbing system.

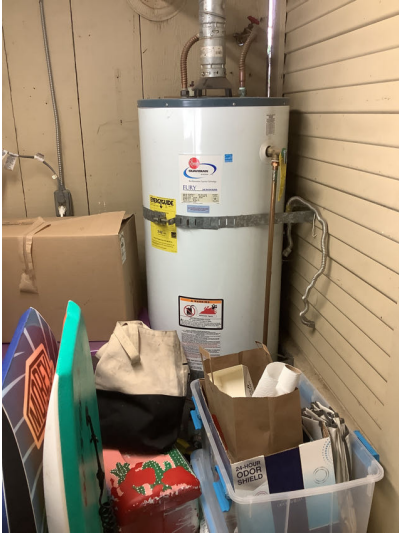
Hot water is provided by a 40 gallon gas water heater that is located in the laundry room.

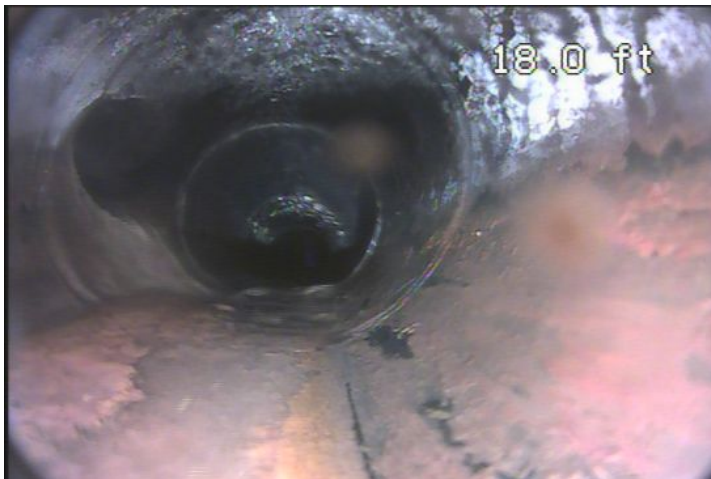
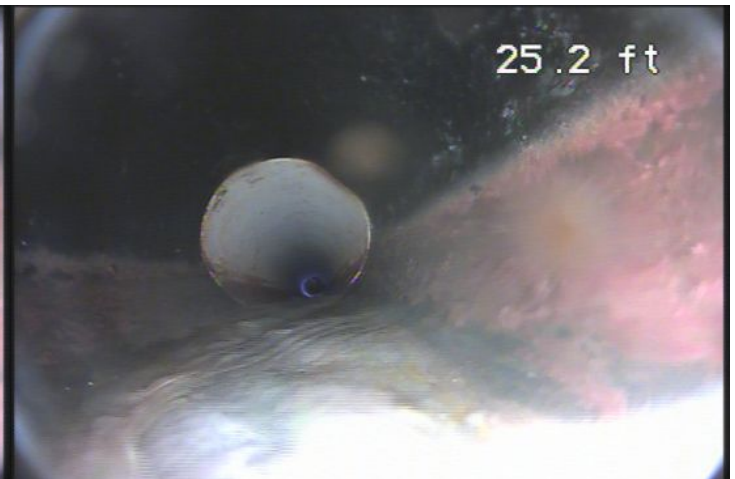
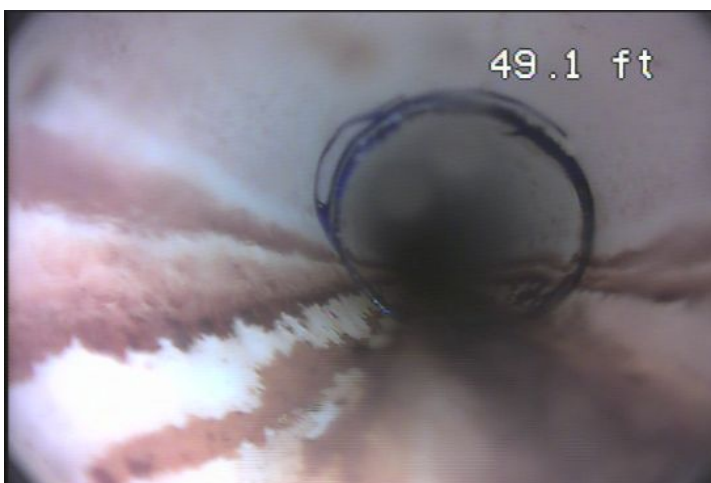
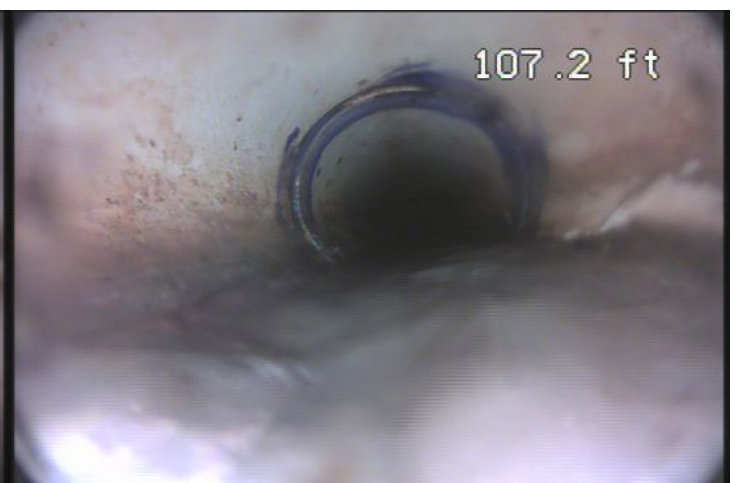
Drain waste pipe connection

6.5. There is root growth present, in the clay pipe connections, which is commonly a result of a damaged drain line or void in a joint. We recommend further review and repair as needed.

6.6. There is a low point in the drain line, which will promote clogging. We recommend further review and repair as needed.

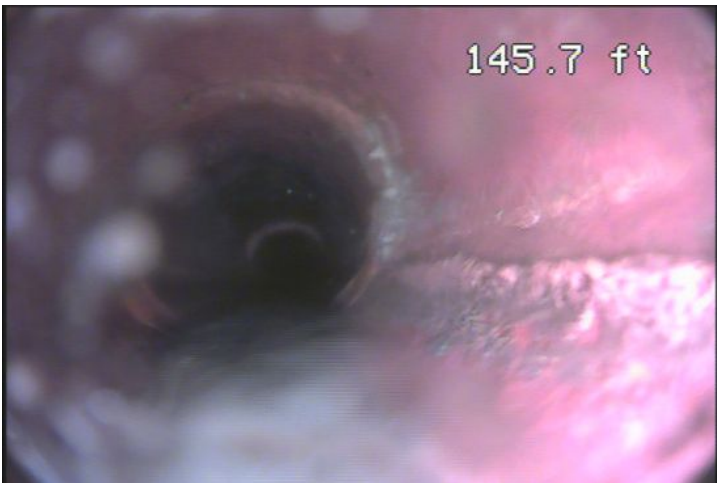
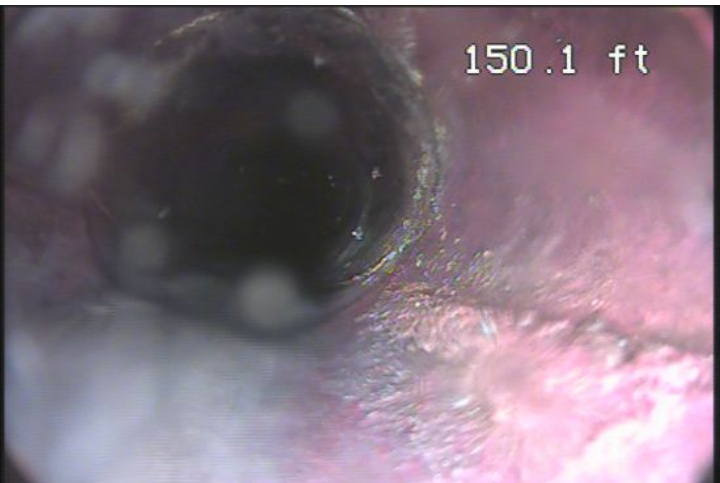
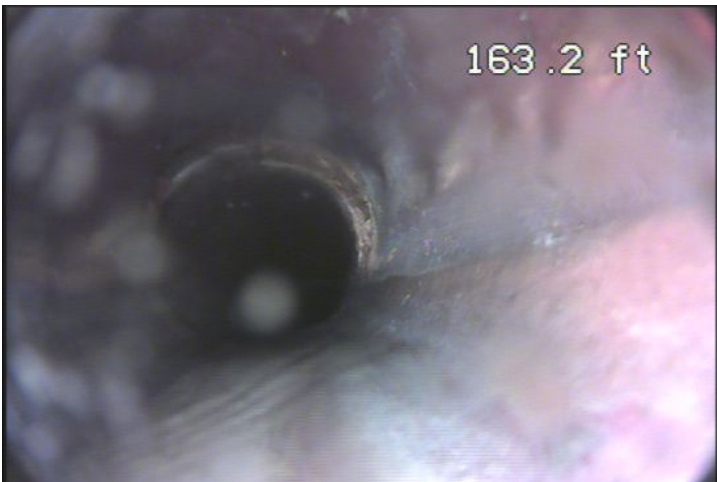
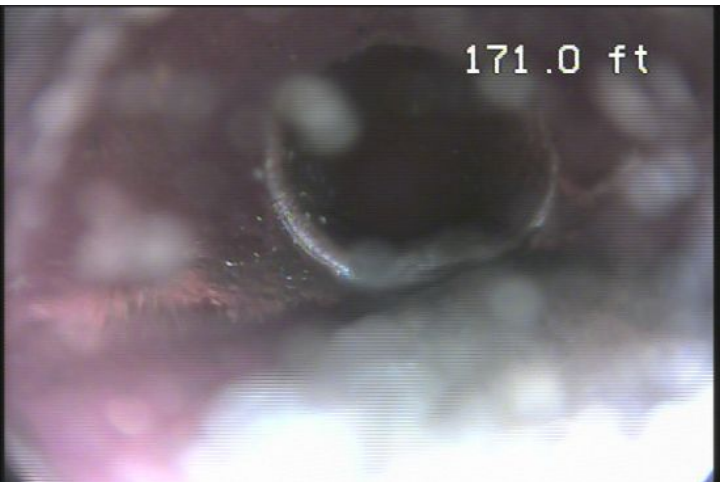
Drain waste pipe connection

There is root growth present, in the clay pipe connections, which is commonly a result of a damaged drain line or void in a joint. We recommend further review and repair as needed.

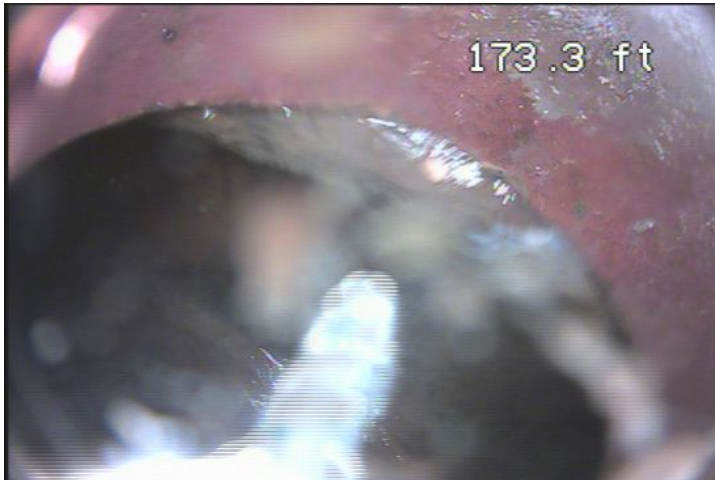
We entered the drain waste drain lateral pipe at the rear house and reached the city main at about 173 feet. Both homes use the same lateral.

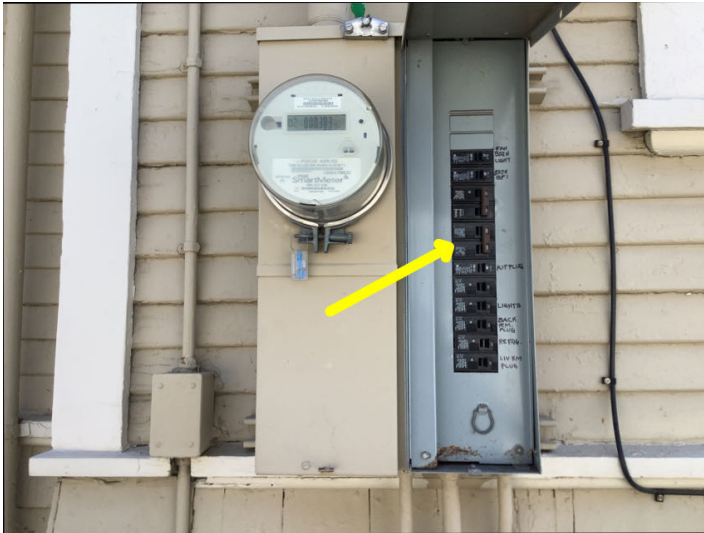
Main electrical service disconnect(Shutoff)

Page 30 Item: 1	Main Electrical Panel	1.14. Various circuits are not labeled, which is recommended.
-----------------	-----------------------	---

1.14. Various circuits are not labeled, which is recommended.

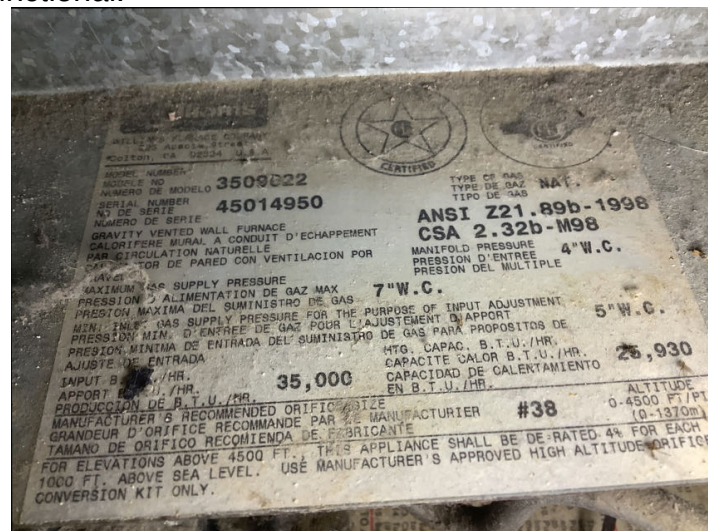
Furnace Brand--Williams Model--3509-022 Manufactured 2001

- 1.1. Heat is provided by a wall furnace located in the living room. Such furnaces are among the oldest and least efficient of heating systems.
- 1.2. The wall furnace is functional.
- 1.3. The vent pipe is functional.
- 1.4. The gas valve and connector are in acceptable condition.
- 1.5. The thermostat is functional.

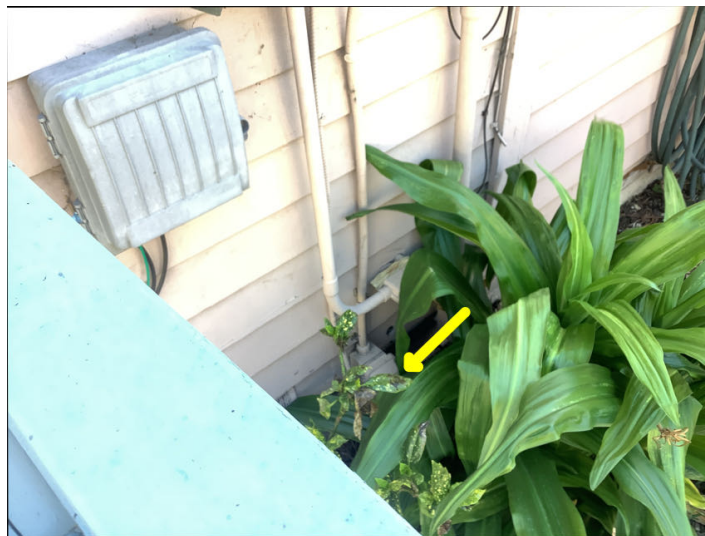
6.2. An outlet at the rear has an open-ground, has a reversed-polarity and should be evaluated and serviced by a licensed electrical contractor.

An outlet at the rear has an open-ground~~~has a reversed-polarity and should be evaluated and serviced by a licensed electrical contractor.

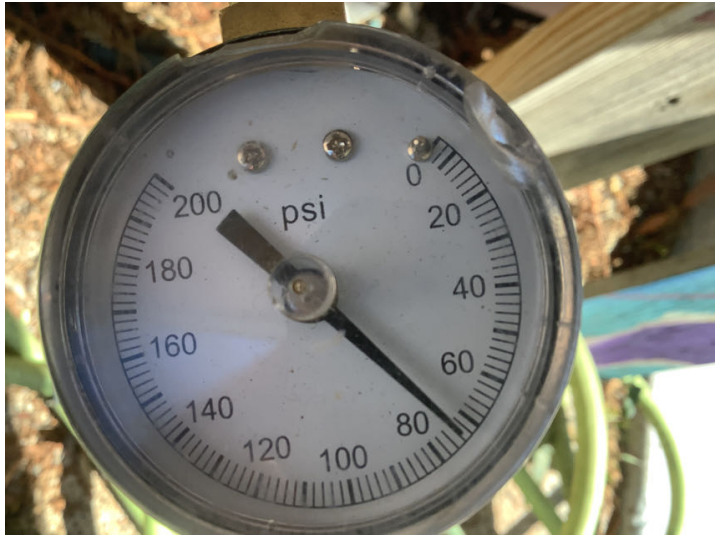
The water pressure entering the residence is under 80psi and a regulator is not required on the plumbing system.

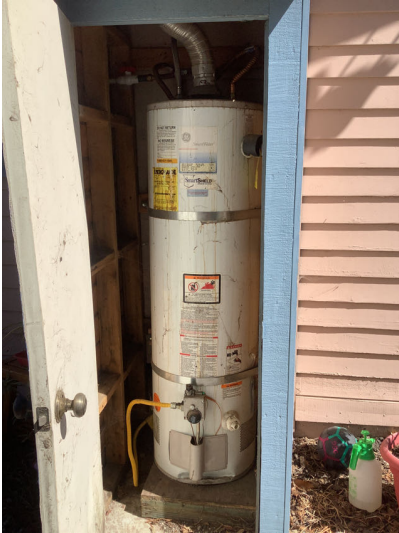
Hot water is provided by a 40 gallon gas water heater that is located in the exterior closet.

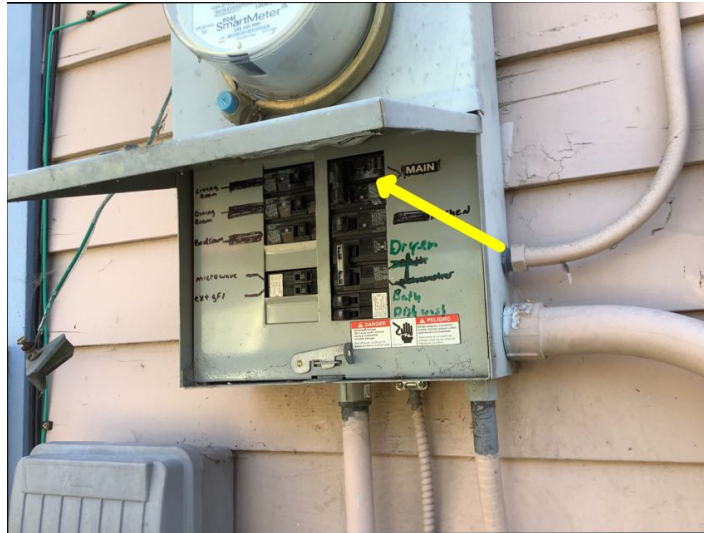
Main electrical service disconnect(Shutoff)

1.11. Current standards require the panel to be double-grounded, and you may wish to consider having this done as a safety upgrade. However, such an upgrade is not currently mandated.

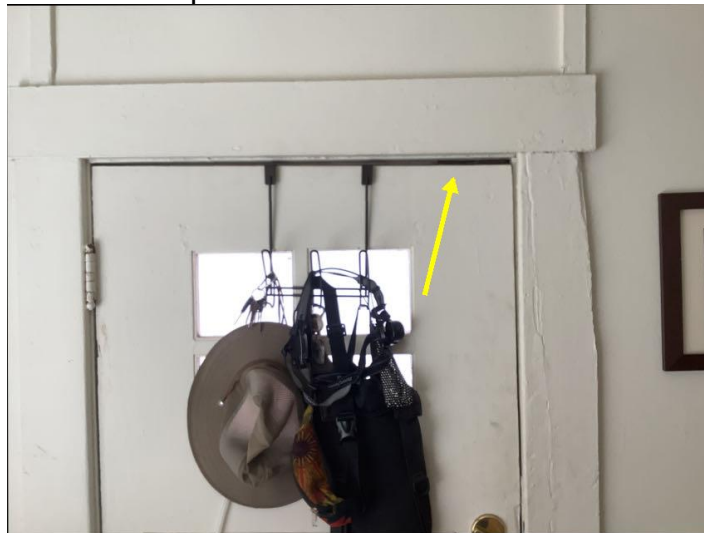
1.1. A door is not square in its opening, which is a result of structural movement. we will elaborate on this issue, but you should have a specialist evaluate.

A door is not square in its opening, which is a result of structural movement. we will elaborate on this issue, but you should have a specialist evaluate.

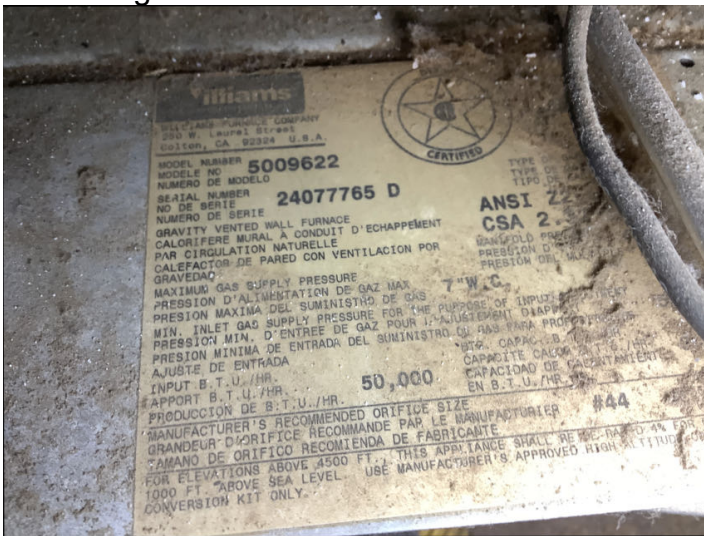
Furnace Brand--Williams Model--5009622 Manufactured 2007

- 1.1. Heat is provided by a wall furnace located in the living room. Such furnaces are among the oldest and least efficient of heating systems.
- 1.2. The wall furnace is functional.
- 1.3. The vent pipe is functional.
- 1.4. The gas valve and connector are in acceptable condition.
- 1.5. The thermostat is functional.
- 1.6. The thermostat is not in the best possible location for the optimum performance and efficiency of the system, and you may wish to have an HVAC contractor apprise you on the advantages of relocating it.
